Riparian Health Summary Final Report

- Paddle River – Upstream of Paddle River Dam Reservoir

Alberta Riparian Habitat Management Society
(Cows and Fish)

December 2010

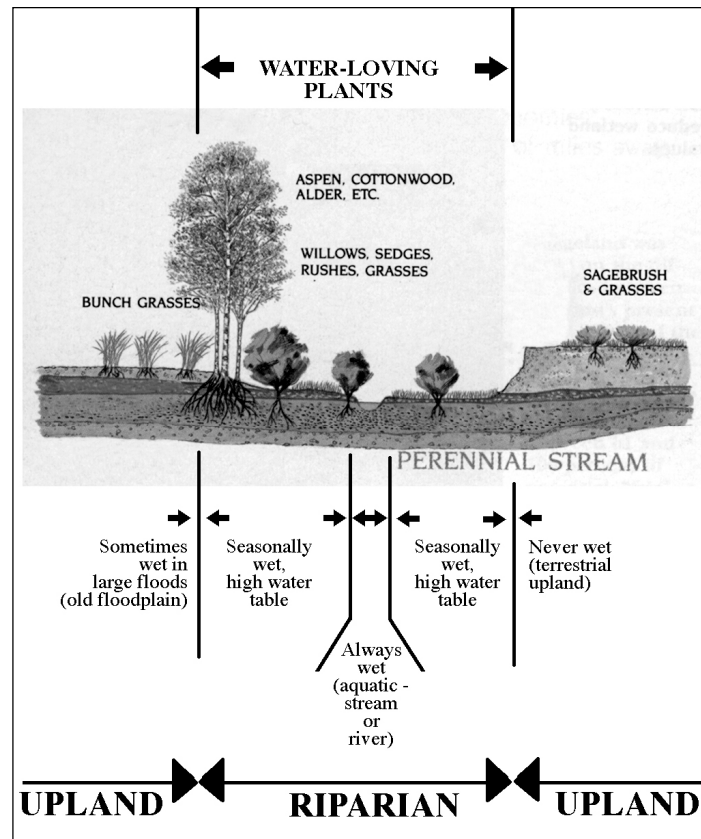
Figure 1 Diagrammatic Representation of a Riparian Area¹

Riparian areas are the portions of the landscape strongly influenced by water and are recognised by water-loving vegetation along rivers, streams, lakes, springs, ponds and seeps (Figure 1). Riparian areas can be described as the “green zones” around lakes and wetlands and bordering rivers and streams.

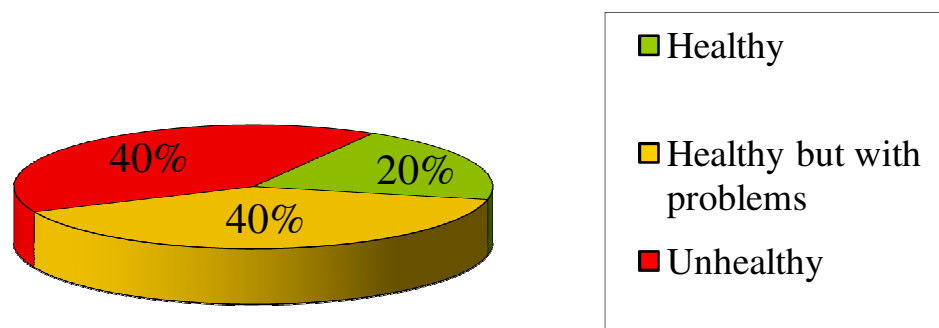
Figure 3 Paddle River Project Area Riparian Health Score Results

Paddle River (upstream of the Paddle River Dam Reservoir) Project Area: Overall Health
(10 Sites)

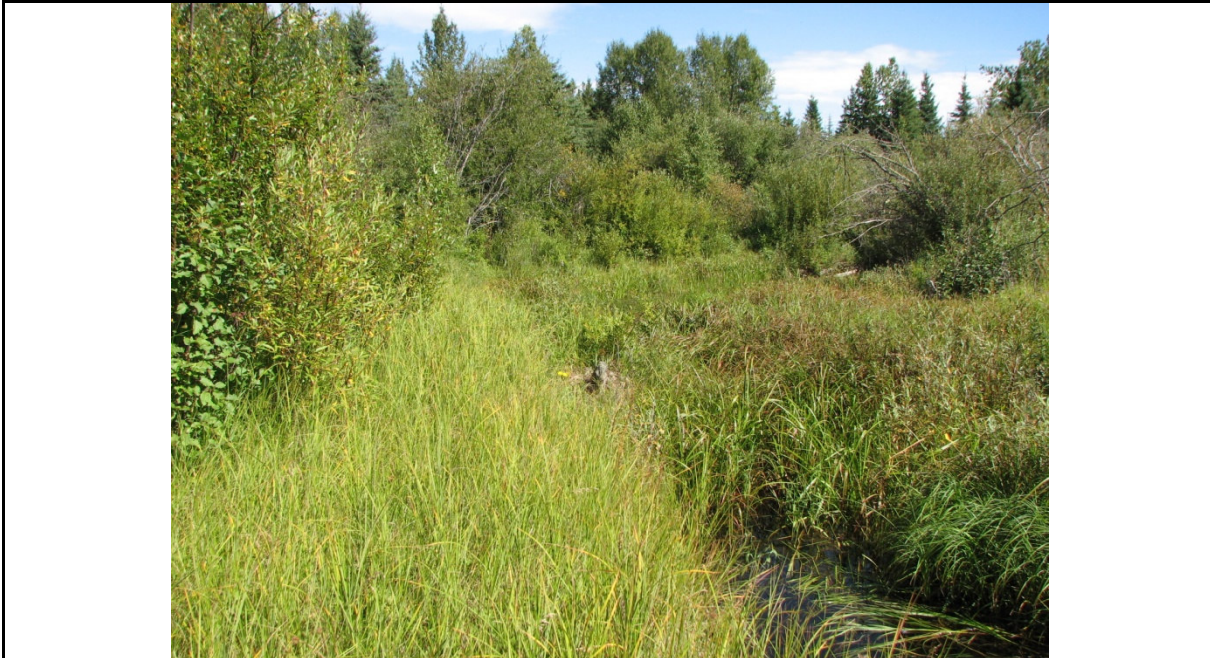
Example of a riparian area along Paddle River rated as “Healthy”

Photo a: Healthy plant community along banks and floodplain. A diversity of native trees, shrubs, grasses and forbs are present. Channel is narrow and banks are gently sloping (not incised). There are no visible physical alterations to the riparian area. (Photographer: K. Adair, RHIP15PAD007)

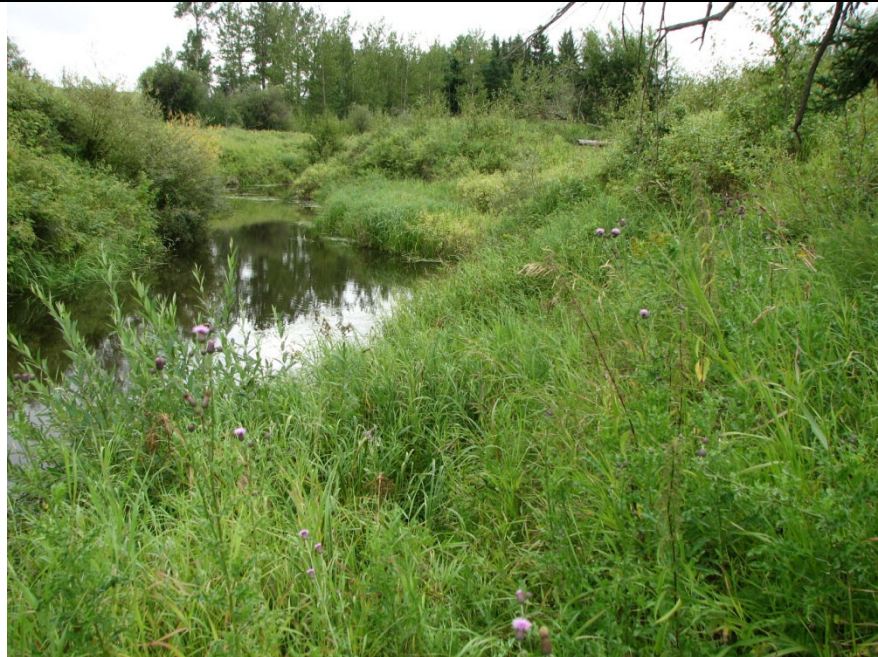
Example of a riparian area along Paddle River rated as “Healthy but with problems”

Photo b: Vegetation cover is excellent though the species composition has more introduced and invasive species (e.g. smooth brome and Canada thistle can be seen in the foreground). The banks are vegetated but steeper and the channel is lower in the floodplain indicating some incisement. New terraces of herbaceous perennial plants are well established within the high banks. (Photographer: K. Adair, RHIP13PAD013)

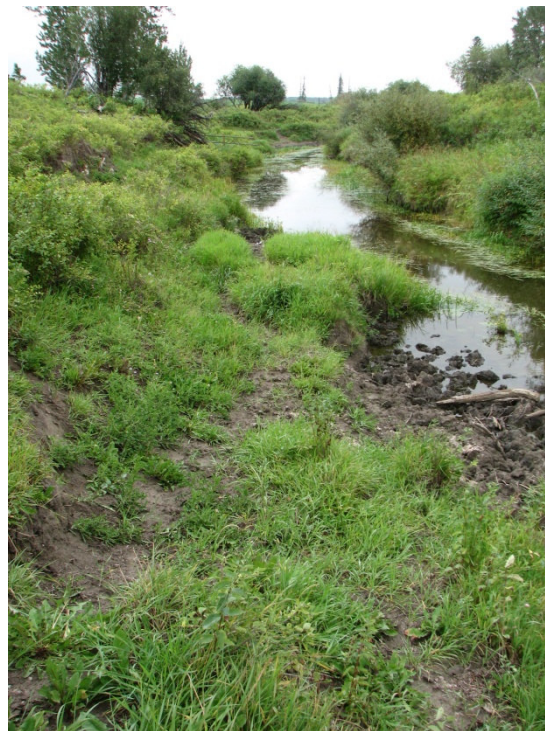
Example of a riparian area along Paddle River rated as “Unhealthy”

Photo c: Left bank has bare ground and physical alterations (hoof shear) adding to instability of the channel throughout the photo. There is a lack of preferred woody plants along the steep banks but there is some woody plant component present. (Photographer: D. White, RHIP12PAD013)

- ***Reduce livestock access and other human activities along the banks and within the active floodplain*** to allow structurally altered and damaged areas time to heal and the potential exists for this recovery. Limiting livestock access with distribution tools (photo k, page 23), rotation and timing will provide opportunity for areas of bare ground to become vegetated, for deep-rooted woody plants to become established or continue to grow. These plants will help trap sediment to rebuild stream banks, and protect against lateral cutting and erosion. Once again, rest is needed during the sensitive portions of the growing season such as early spring to promote recovery.

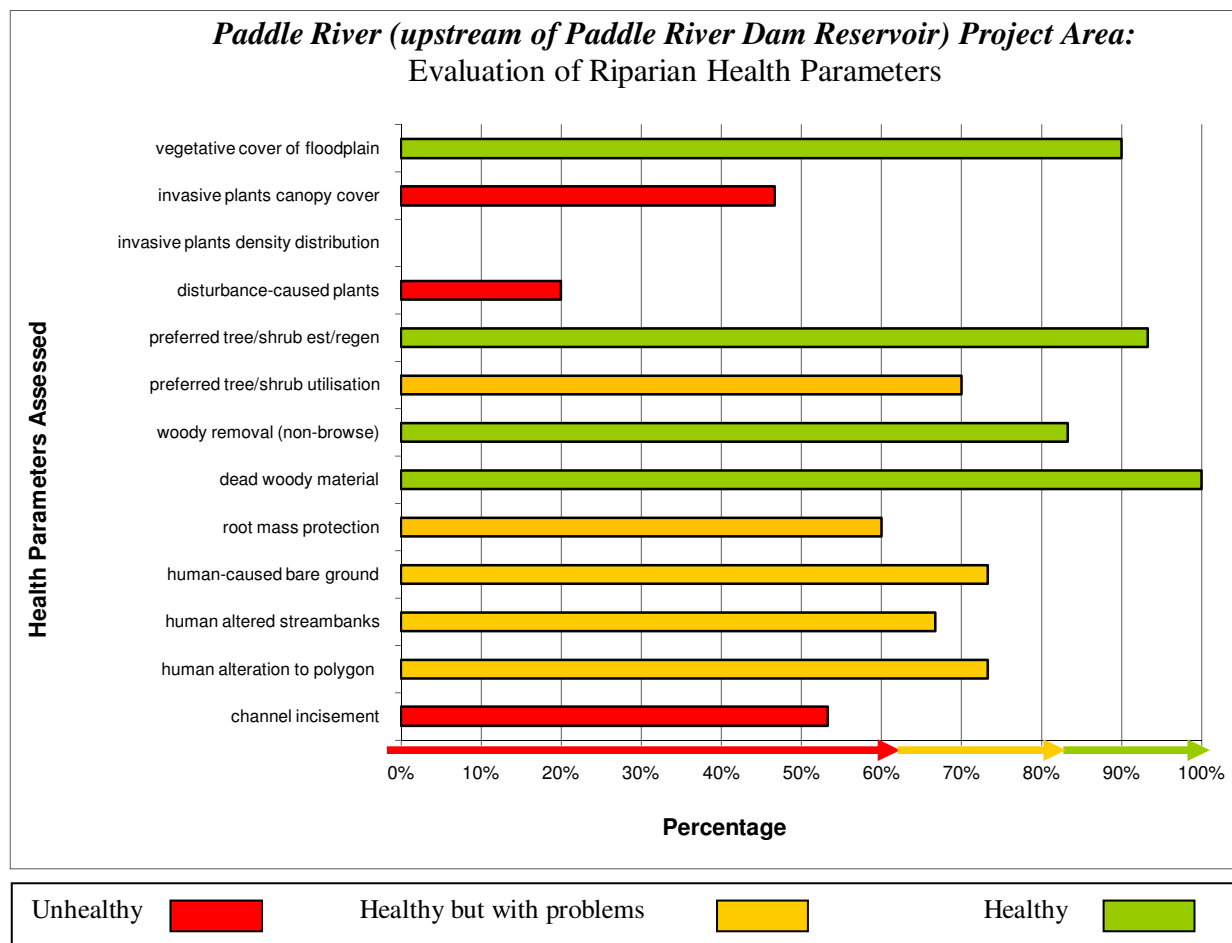
Figure 4 Breakdown of Riparian Health Parameter Ratings for Paddle River

Collectively the vegetation parameters in the project area were rated as *healthy but with problems* (69%). Riparian areas are well vegetated with a diversity of plant species. Refer to **Appendix C** for a list of all plants found in the Paddle River project area.

Soil/hydrology parameters in the project area were rated as *healthy but with problems* (63%). Human-caused bare ground is present in most areas and root mass protection along the banks is moderate. There are some concerns with human-caused alterations to the riverbanks and floodplain. Channel incisement scored the lowest for soil/hydrology parameters suggesting water in the channel does not get out on the floodplain on a regular basis which can over time affect riparian integrity and health.

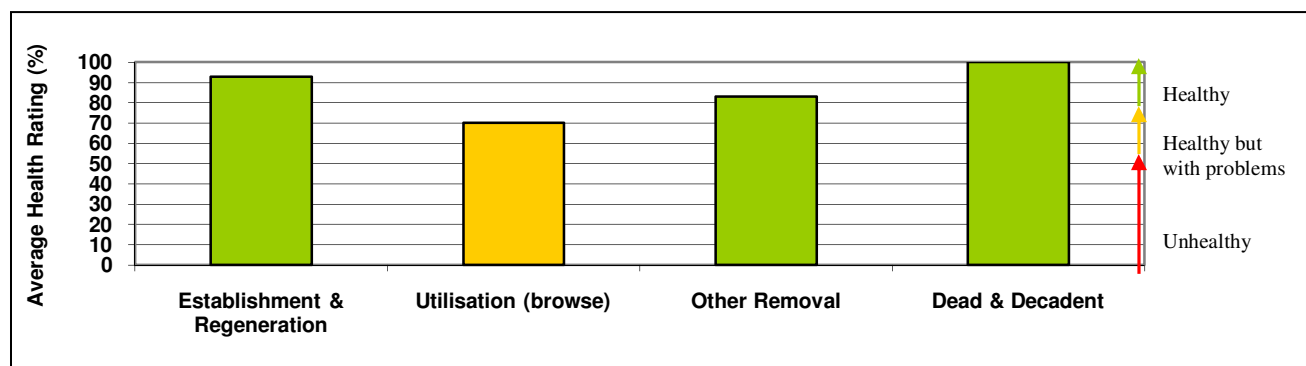
Figure 5 Paddle River Woody Plant Parameter Health Ratings

- White spruce (*Picea glauca*) and balsam poplar (*Populus balsamifera*) are the dominant trees occurring in the project area. Shrubs with a significant presence are buckbrush/snowberry (*Symphoricarpos occidentalis*), Drummond's willow (*Salix drummondiana*) and beaked/Bebb's willow (*Salix bebbiana*).
- 11 of the shrubs recorded are willow species and many others are indicative of moisture-rich habitats.

Existing tree and shrub communities show normal amounts of dead and decadent branches in the upper canopy. This indicates there is sufficient moisture within the system, and that disease, insect infestation or spray drift is not a problem in maintaining these communities. In 50% of sites, preferred trees and shrubs species are receiving light browse pressure from livestock and wildlife. Woody plants can sustain low levels of use, but increased browsing can deplete root reserves and inhibit establishment and regeneration. Two sites display signs of heavy browse pressure. The indicators of heavy browse pressure are umbrella-shaped mature shrubs (photo e, page 21) and flat-topped or hedged seedling and saplings.

Monitor browse pressure on trees and shrubs and reduce where heavier. Trees and shrubs that are considered preferred in terms of riparian health also tend to be those that are most palatable to livestock (e.g. red-osier dogwood). Browsing tends to occur most in the fall and winter after grasses have matured or in spring before grass begins growth. Early in the growing season, trees and shrubs are also very palatable along with the younger age class seedlings and saplings. Where there have been plantings of trees or shrubs along the riparian area it is highly recommended that livestock are excluded from those areas for the first years until the plantings can get established.

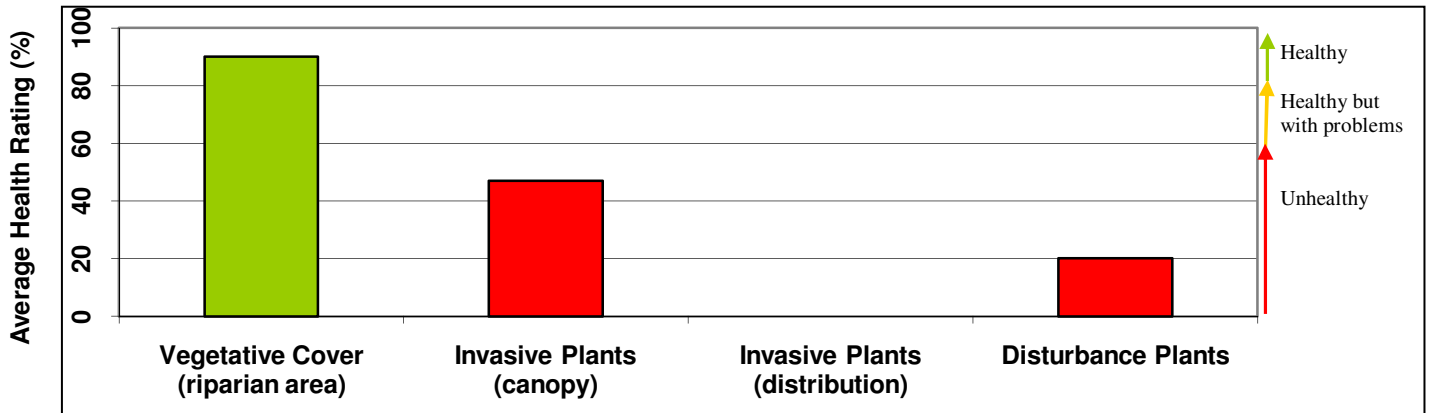
Figure 6 Paddle River Vegetation Cover and Composition Health Ratings

All sites have adequate amounts (greater than 85%) of plant cover in the riparian area and most have greater than 95% cover. Disturbance-caused undesirable herbaceous species as well as invasive species are prevalent in the project area. Disturbance plants are typically non-native grasses and forbs (broad-leaved flowering plants) that aggressively displace native plants once the soil surface has been disturbed. Invasive plants are those that are listed by the *Weed Control Act of Alberta* as **restricted** or **noxious** weeds. They are non-native species that spread rapidly and are difficult to control.

- Seven of the ten sites have more than 50% of the riparian area covered in disturbance-caused undesirable herbaceous species. Overall, these species cover approximately 42% of the project area. Of the 21 disturbance-caused plants present, the most prevalent is

- **Prevent an increase in the presence of disturbance-caused plants.** Complete elimination of disturbance-caused plants is not realistic. However, with sound grazing strategies the prevalence of disturbance-caused plants could be reduced. From a grazing perspective, disturbance-caused plants do provide some forage for livestock at specific times of the year but require specific management, as they “green up” and mature earlier than most native grasses. Providing maximum rest during the growing season, skim grazing and time-controlled grazing management practices can be applied, to reduce the potential for an increase in these species while maintaining an abundance of native species.

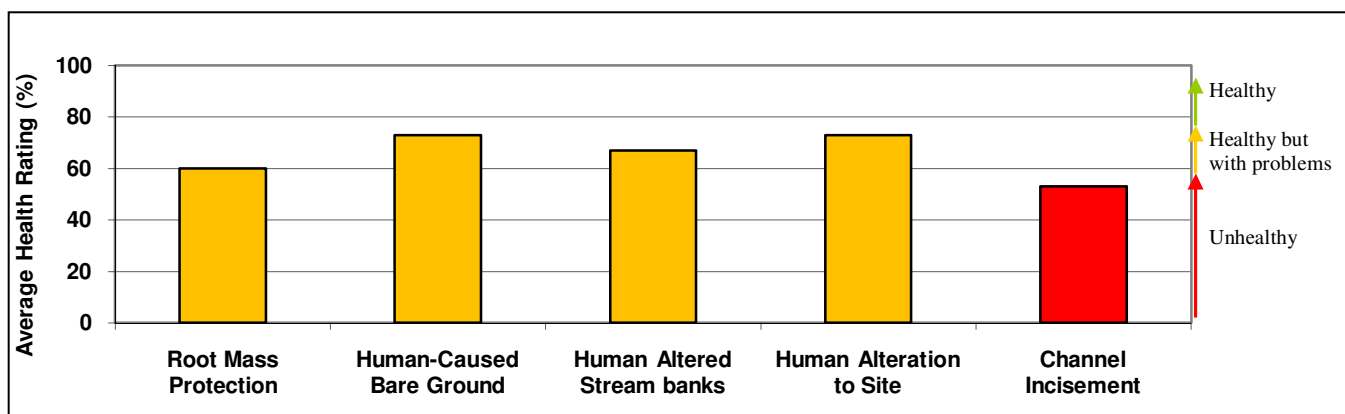
Figure 7 Paddle River Soil and Hydrology Health Rating

- The amount of bare ground overall in the project area is minimal at only 3% of the total area. The majority of this is caused by human activity or that of our agents (i.e. livestock). Depending on the site the amount of human-caused bare ground is highly variable ranging from less than 1% up to 15%.

- Overall, the banks of Paddle River are in fair condition with 14% of the bank length within the project area having structural alterations caused by human activities. Almost all (98%) of the alterations are due to grazing activities. Only one site had more than 35% of bank length structurally altered by human activity. Half of the sites had 5% to and 35% altered bank with the remaining three sites having less than 5% altered bank.
- The riparian area beyond the banks is slightly better. Overall, about 8% of the project area (excluding the banks) has human caused alterations. Five of the ten sites have less than 5% of this area physically altered by human causes. The remainder have 5% to 25% alterations. Soil compaction as a result of primarily grazing accounts for the alterations. A small amount could be attributed to construction or use of machinery.

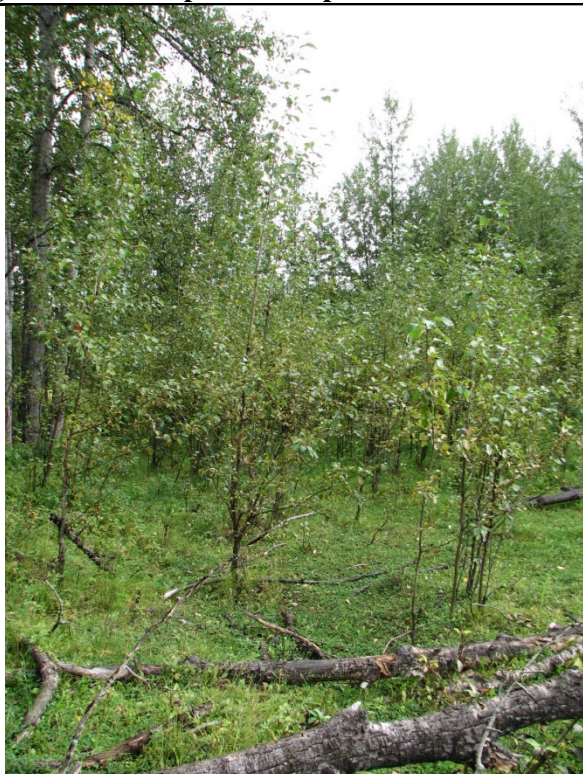
Photo d: Sign of balsam poplar regeneration within the riparian area. These seedlings and saplings represent the future of the woody plant community along the Paddle River. Although poplar is a seral stage of the mixed wood forest, they are necessary for promoting succession. (Photographer: D. White, RHIP16PAD012).

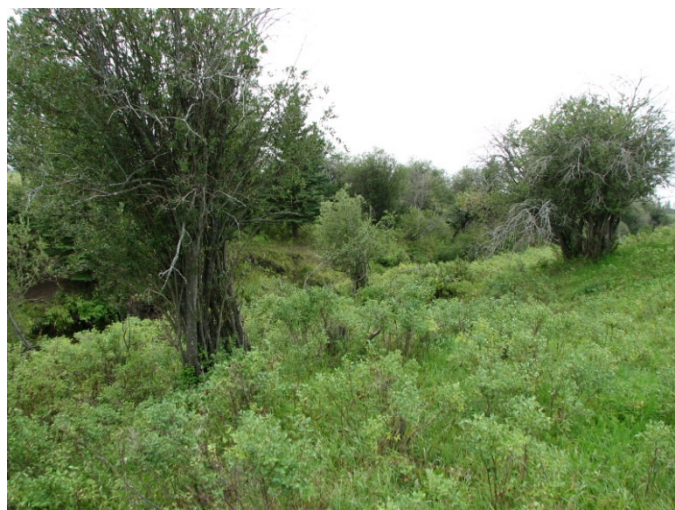
Photo e: Long term browse utilisation on woody plants is apparent here in the umbrella or mushroom shape of the mature willows. Snowberry/buckbrush in the understory indicates heavier pressure in the past as well. We can learn a lot from plant communities. (Photographer: D. White, RHIP12PAD006).

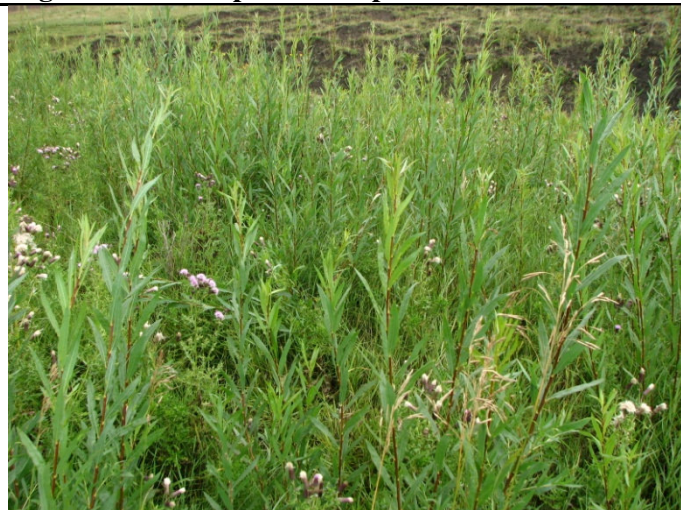
Photo f: Young willows growing along the bank and lower floodplain represents the potential for the slightly wetter portion of the riparian area. These deep rooted woody plants will trap sediment, bind the existing soil and promote both physical and vegetation recovery in the riparian area. (Photographer: K. Adair, RHIP17PAD012).

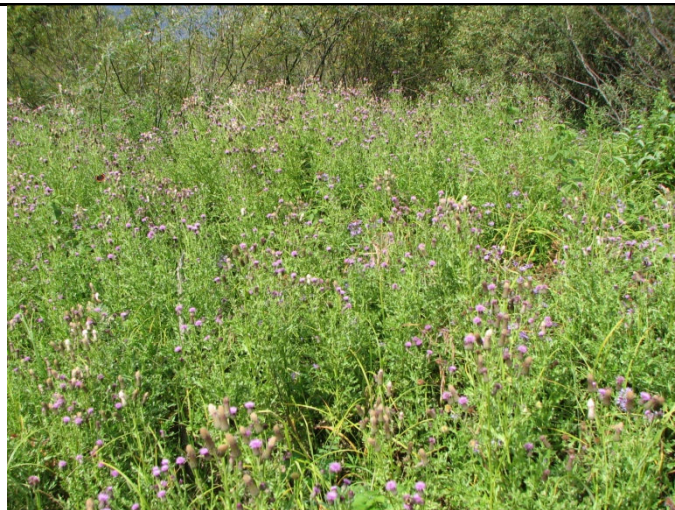
- Despite the abundance of disturbance-caused plants, native grasses and forbs continue to be maintained within the project area.
- **The prevalence of invasive plants is a concern.** Canada thistle (*Cirsium arvense*) was found in every site. Its distribution in the riparian area ranges from a few scattered individuals to a few patches plus several individual plants. Most sites fall into the latter category. Smooth perennial sow-thistle (*Sonchus uliginosus*) also occurs on all sites. Although it is present in much less abundance than Canada thistle, it too is distributed in a few patches with several individual plants throughout most sites. Tall buttercup (*Ranunculus acris*) occurs on four sites, common tansy on three sites; common caragana (*Caragana arborescens*), cleavers (*Galium aparine*), and yellow toadflax (*Linaria vulgaris*) occur on one site each. The cover and distribution of all of these additional invasive species is low though their presence could lead to future increased infestations. (Photo g, page 22) .

Photo g: A patch of Canada thistle in the riparian area can quickly spread, even among the most well-vegetated of sites, if it is not managed. (Photographer: K. Adair, RHIP15PAD012).

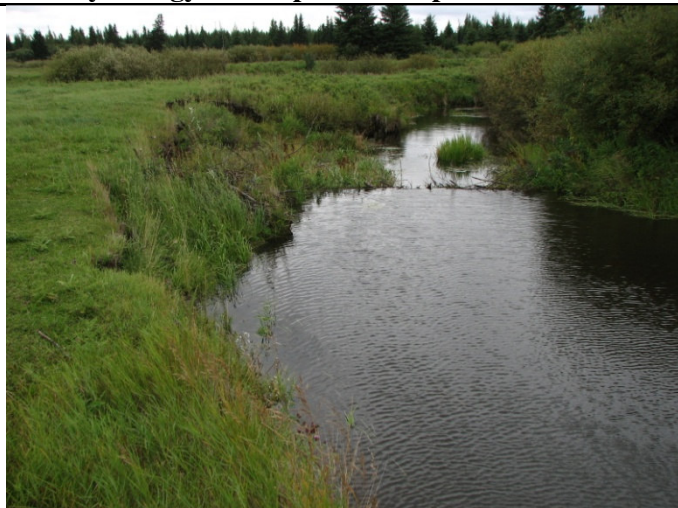
Photo h: Slumping occurring along a stretch of bank (left side) lacking deep rooted woody plants. The right side is well protected. (Photographer: D. White, RHIP09PAD002).

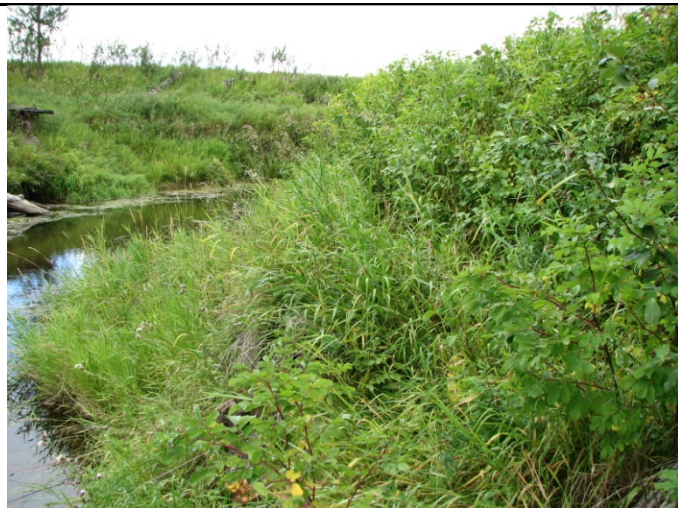
Photo j: Steep banks on both sides of the channel indicate downcutting in the past. This can be a deterrent to livestock access. Maintaining vegetation cover on these sensitive banks is key for overall riparian health. (Photographer: K. Adair, RHIP05PAD002).

- ***Channel incisement*** is a difficult aspect of riparian health to understand and manage. Sometimes it is a part of the natural process of a stream as it makes its way from a higher gradient to a lower gradient. However, incisement can also be a result of changes in the watershed that might create more water volume and energy in the stream at times that are not “normal”. When water has more energy it has more power to erode laterally and vertically and thus a stream can become incised. For example, culverts and road crossings that are improperly placed or sized can have this effect. Loss of critical tree and shrub communities along the length of the Paddle River (and within the watershed) can also increase channel incisement because the buffer, which can slow down water and thus reduce water energy, is removed. Restoring tree and shrub communities and maintaining existing vegetation in riparian areas will reduce the rate at which incisement may continue. It can also assist by trapping sediment to begin the process of recovery even though it may never be restored to the stage it once was. It may also be necessary to look at the rest of the watershed to manage and reduce increased runoff and to address other potential issues that may be influencing this parameter of riparian health.

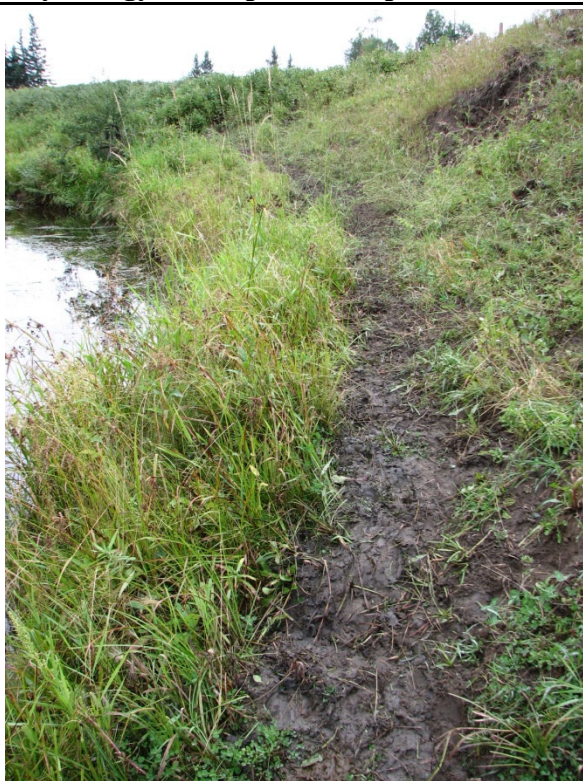
Photo j: Trailing close to the water edge creates compaction and bare soil, adding to alteration of the physical structure and making this bank vulnerable to erosion and weed infestations. (Photographer: D. White, RHIP11PAD012)

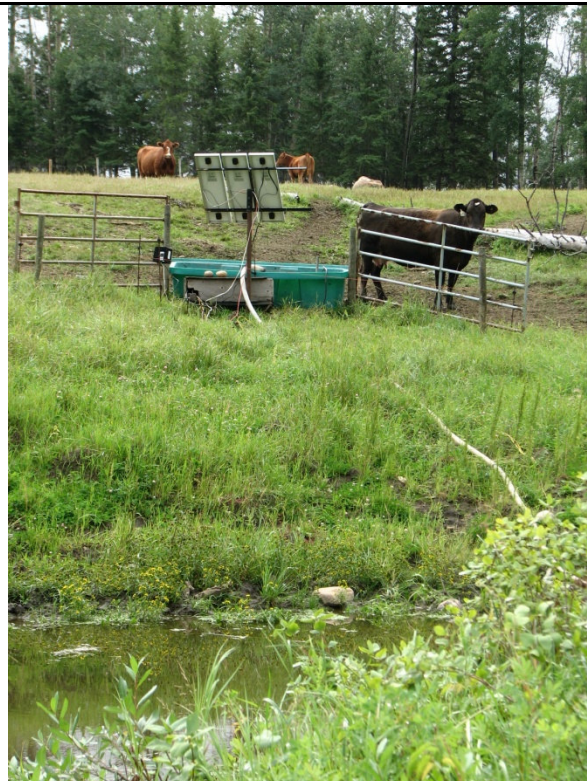
Photo k: Alternative water systems such as this one are an excellent tool for limiting or removing livestock access to surface water. If equipment and lift allowed, this system could be placed further back to avoid the sensitive steep slope behind it. (Photographer: D. White, RHIP12PAD017)

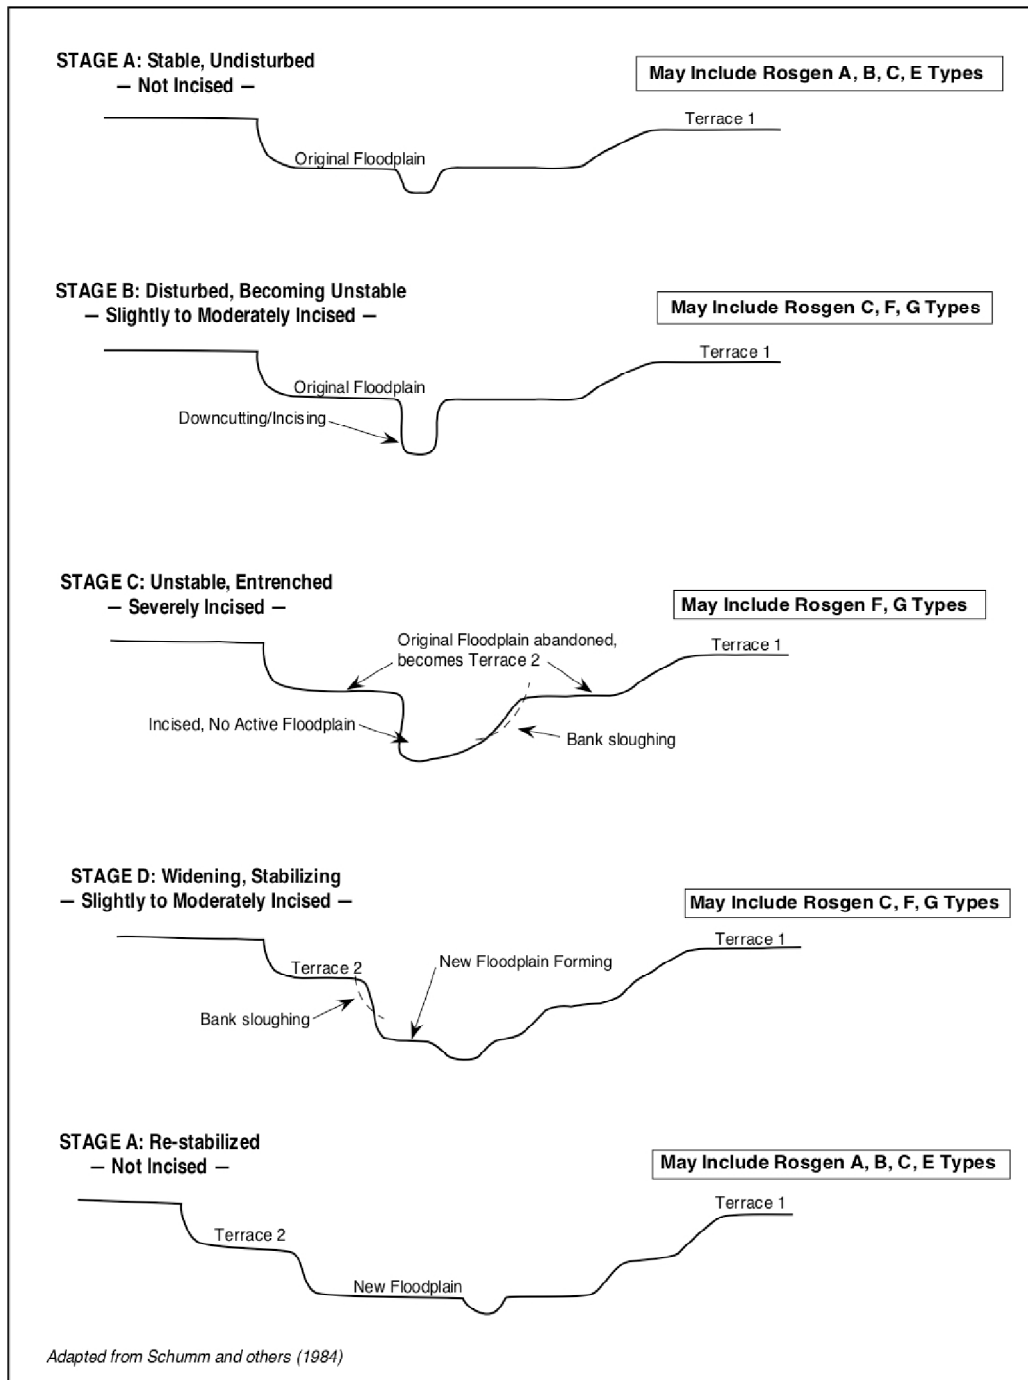
Figure 1. Guide for estimating channel incisement stage.

Incisement Severity	Channel Development Stage	Rosgen Types Included	Description of Incisement Situation
Slightly (6 points)	B/D	C, F, G	This category contains both degrading and healing stages. In either case, the extent of incisement is minimal. In Stage B, the channel is just beginning to degrade, and a 2 year flood event may still access some floodplain, either partially or in spots. Downcutting is likely progressing. In Stage D, the system is healing. Downcutting should have ceased at this stage. A new floodplain should be well established with perennial vegetation, although it may not yet be as wide as the stream type needs. This is indicated by continuing lateral erosion of the high side walls of the original incisement, as the system continues to widen itself at its new grade level.
Moderately (3 points)	B/D	C, F, G	This category also contains both degrading and healing stages. In both cases, the extent of incisement is significant. In Stage B, the channel has downcut to a level that floods of the 1-5 year magnitude cannot reach a floodplain. Downcutting is likely still progressing, but the channel may already have the appearance of a gully. In Stage D, the system has only just begun to heal. A small floodplain along the new meanders within the gully is forming, and perennial vegetation is starting to colonize the new sediment features. The high side walls of the gully are being actively eroded as the system widens, and much of the fallen material is being incorporated along the bottom.

Severely (0 points)	C	F, G	This is the worst case category, where the system has no floodplain in the bottom of a deep entrenchment, and small-to-moderate floods cannot reach the original floodplain level. Downcutting may, or may not, still be in progress. High side wall banks may have begun to collapse and erode into the bottom, but high flows typically just wash this material directly through the system, with none of it being trapped to build a new floodplain. At this stage, the system has lost practically all of its riparian function and habitat value.
